AUSTRALIAN SPORT ROTORCRAFT ASSOCIATION INC

AIRWORTHINESS DIRECTIVE

No. 2008.01
Date: 1 May 2008
Subject: Gyroplane Hub-bars

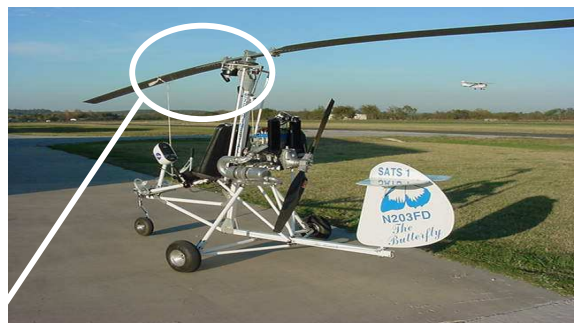
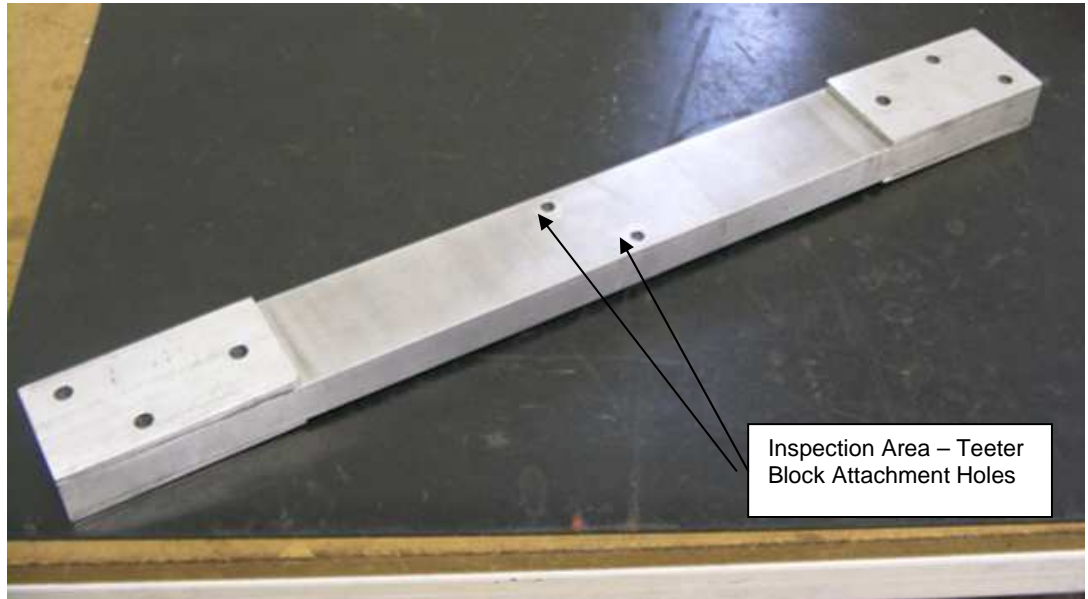
Figure 1: Location of Teeter Block Attachment Holes

101. Recently, an aircraft suffered a catastrophic blade separation during a go-around manoeuvre, which resulted in the total loss of the aircraft and injuries to both crew. Investigations revealed that the Hub Bar failed from a bolt hole that attaches the hub bar to rotor head via a teeter block assembly.
102. The hub bar that failed was manufactured from 6061 T6 aluminium alloy. The failure initiation appeared to originate in a teeter block attachment bolt hole. Catastrophic failure occurred when the defect reached approximately 12mm in length. The defect would not have been visible during pre-flight inspections as propagation was under the teeter block. Figure 1 details the inspection area.

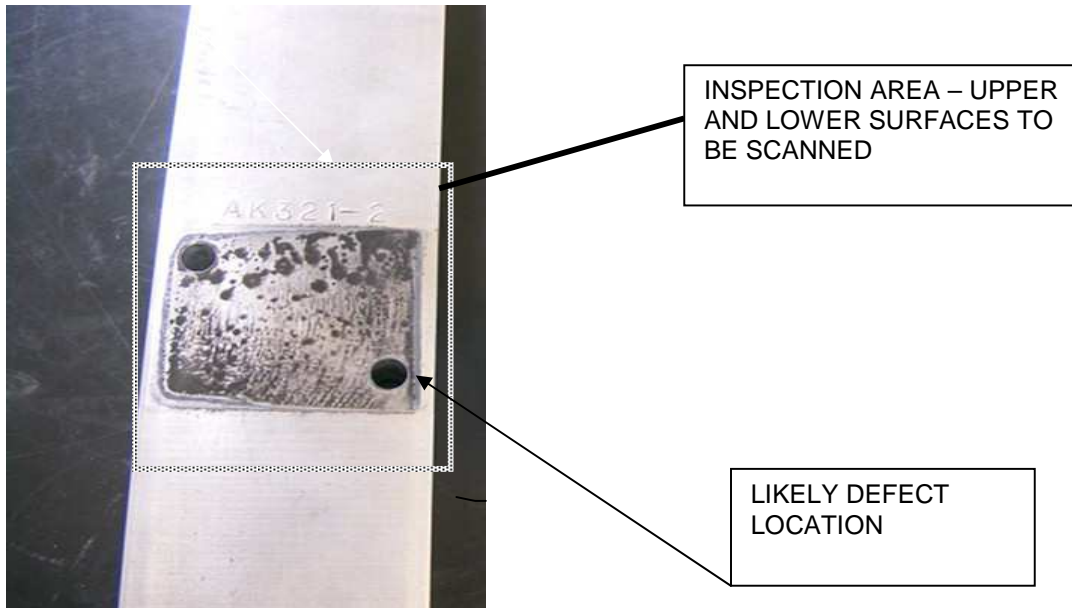
Figure 3: Hub Bar Showing Possible Defect Location and Scan Areas

109. Perform the inspection as follows:
- Place the probe on the inspection surface approximately 2mm from the edge of a teeter block attachment hole.
 - Balance the instrument and check the lift off response.
 - Adjust the phase angle (if required) to achieve a lift off response as shown in figure 2.
 - Scan around both bolt holes on the upper and lower surfaces of the hub-bar.
 - Scan the upper and lower surfaces in an area that will cover 10mm further outboard than the extremity of where the teeter block mounts. Inspection area shown in Figure 3.
 - Mark any repeatable defect indications that cannot be attributed to edge effect or lift-off.

112. Any repeatable defect indication that cannot be attributed to lift off or part geometry is cause for the Hub Bar to be placed unserviceable.

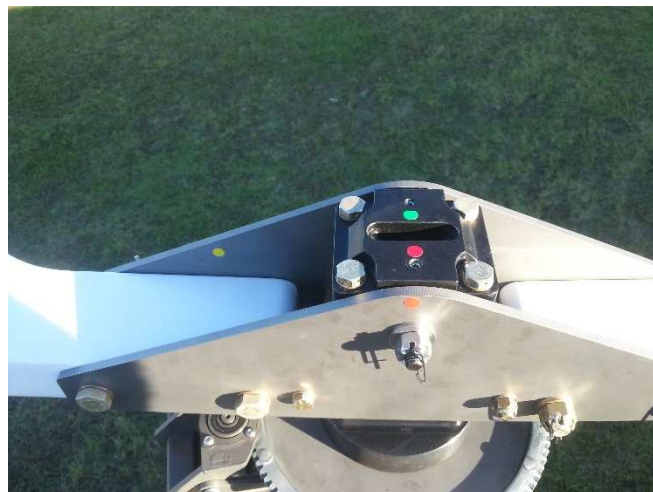
Extensive research has revealed that there have been no known failures or defects detected in the hub-bars currently fitted to these gyroplanes most likely indicating that the "side plate" design (photo below) is not prone to the fairly predictable onset of cracking and very occasional catastrophic separation known to occur in conventional aluminium hub bars substantially exceeding 1000 hours time in service. Additionally, the eddy current testing process described within the AD is only relevant for deep holes in thick metals.

Dispensation. Gyroplanes manufactured by Magni Gyro Company and TAG Aviation that utilise the hub-bar design pictured above are exempted from the requirements of ASRA AD 2008.01. Testing and life of these hub-bars is as per manufacturer's recommendations or requirements. This dispensation is only applicable to hub-bar designs similar to that pictured.
