# AUSTRALIAN SPORT ROTORCRAFT ASSOCIATION INC

## AIRWORTHINESS DIRECTIVE

**No: 2014.01**

**Subject: Gyroz Gyroplanes – rudder cable mounting bracket**

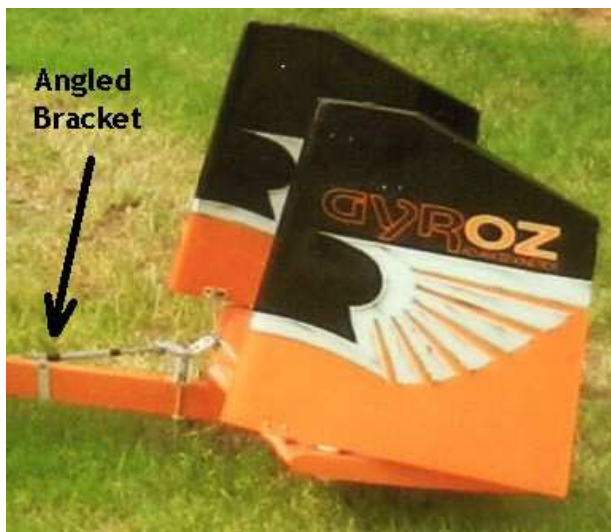
**GYROZ forward keel clamp**  
**Material 6061-T6**

The picture on the left below shows the arrangement of the keel brackets as depicted in the G511 registration photograph. The foremost keel bracket is angled to allow for the rudder push-pull cable to angle upwards to meet the bellcrank. It will be obvious to all readers that if the angled bracket loosens at the top bolt (as occurred in this fatality)

then the angled bracket will pivot to the vertical and over to an equal amount as it does when clamped and secured tilting forward.

By studying the geometry of the bracket in the registration photograph it is easy to see that if the angled clamp tilts (pivots) to the rear, the bellcrank will further pivot to cause the all-moving vertical stabilizers to deflect harshly inducing a severe right yaw.

**Minimum thickness 0.160"**  
**Lightening hole optional**

To maintain the upward angle of the push-pull cable, it will be necessary for a new set of side plates for the clamp - now secured by 4 AN4 bolts - to be fabricated so that rearward pivoting of the clamp will then become impossible. See the picture to the right. Note that the forward edge of the replacement sideplates is to be cut at precisely the same angle as the existing 2-bolt clamp. Workmanship is to be of a very high standard.
