SAFETY ALERT

No: SA 2016.01

Subject: ELA Mast Cracks

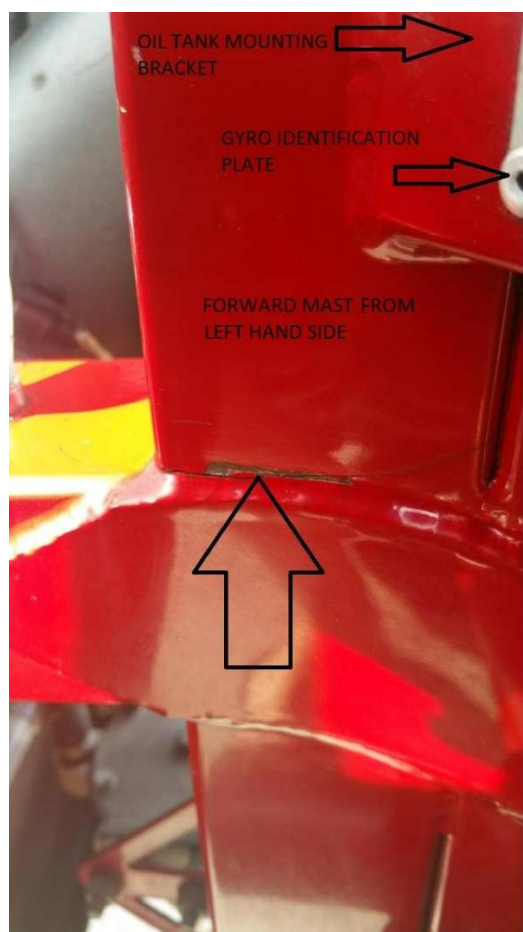
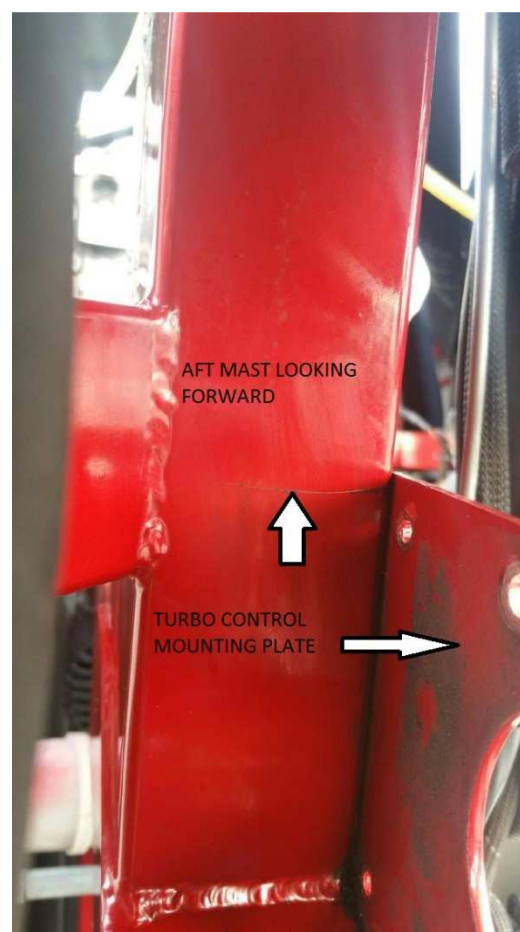
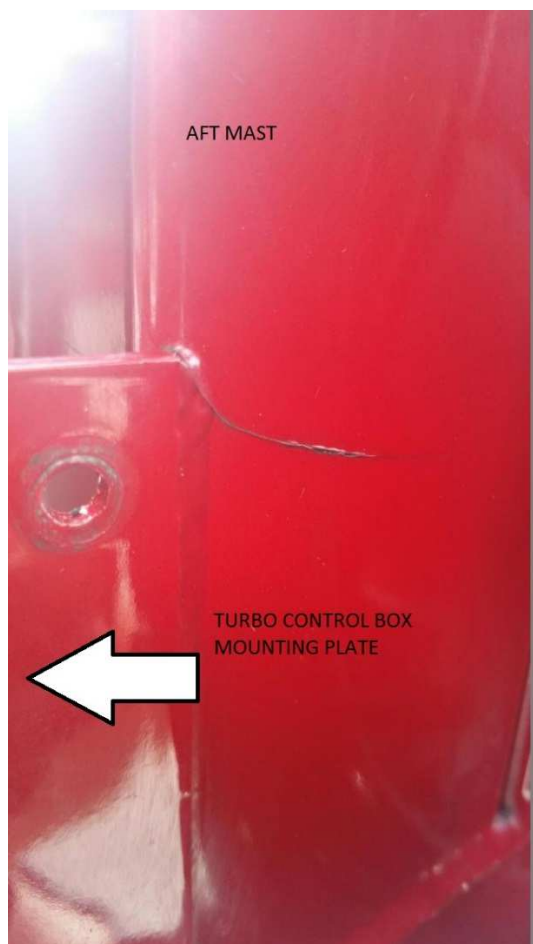
The owner of an ELA gyroplane has reported finding cracks in the mast of his gyro during a routine pre-flight inspection. Close inspection revealed that the mast was cracked on both the forward and aft faces of the mast in the region of the welds between the mast and the upper keel junction.

The reader should realise that the airframes are powder coated and due to the elasticity of that material, cracks may not be visible until they are well advanced.

The manufacturer was contacted and advised that there was no suitable repair available and that a new airframe would be required.

ALERT: ASRA strongly recommends that the owners, operators and pilots of all types of gyroplanes that utilise welded alloy airframes pay particular attention to the airframes in the vicinity of welded joints during pre-flight inspections and regularly during their daily operations for indications of airframe cracking.
