AUSTRALIAN SPORT ROTORCRAFT ASSOCIATION INC

AIRWORTHINESS DIRECTIVE

No. 02/2004
Date: Thursday, 21 October 2004
Subject: Larkin Hub-bars

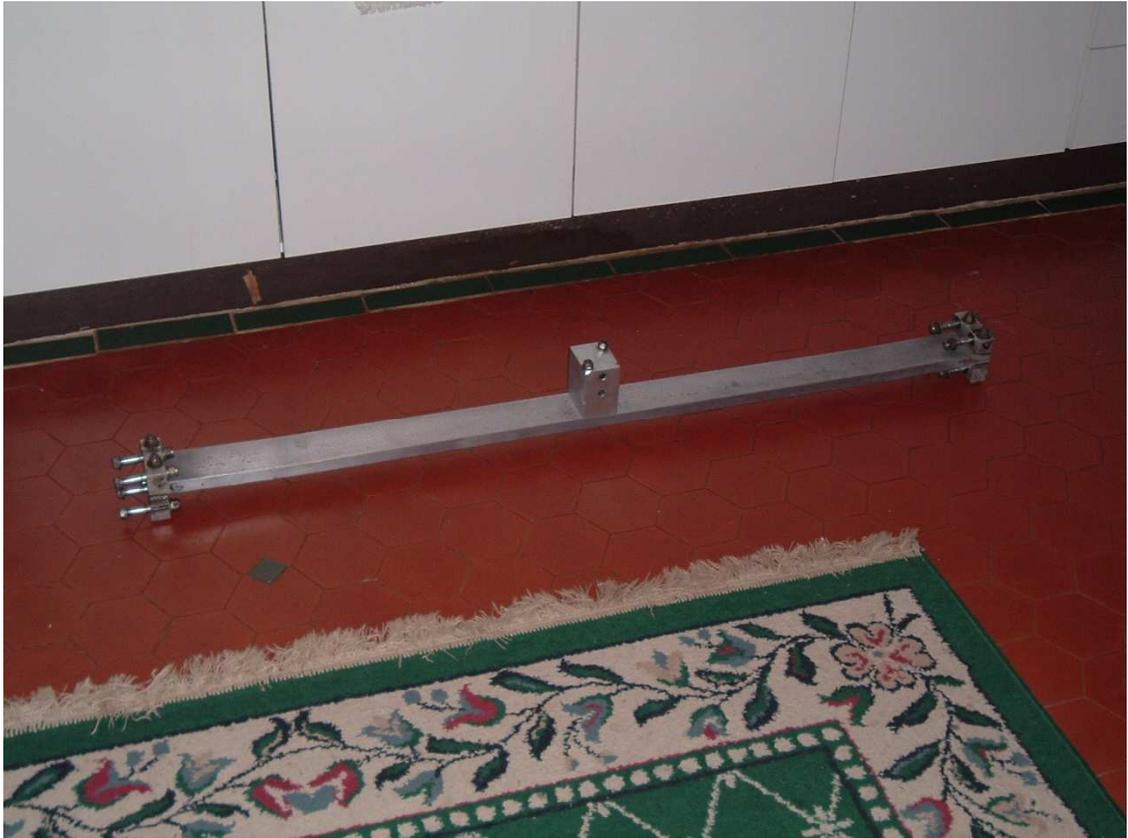
Larkin hub-bars are manufactured from aircraft grade 2024 T3 aluminium which, although stronger than 6061 T6 is more brittle and is affected by corrosion to a greater degree. They may be identified by serial numbers that have a format similar to "123 + 8L". A photograph is attached to assist with identification.

All gyroplanes registered with or operated by ASRA members that are fitted with Larkin blades are grounded forthwith.

These gyroplanes must not be flown until the Larkin hub-bar is replaced and the modification is inspected and approved by a suitably qualified ASRA Technical Adviser.
