# AUSTRALIAN SPORT ROTORCRAFT ASSOCIATION

## AIRWORTHINESS ALERT

**No. AA 2008.01**

**Subject: RAF 2000 and Derivatives - Control Tube**

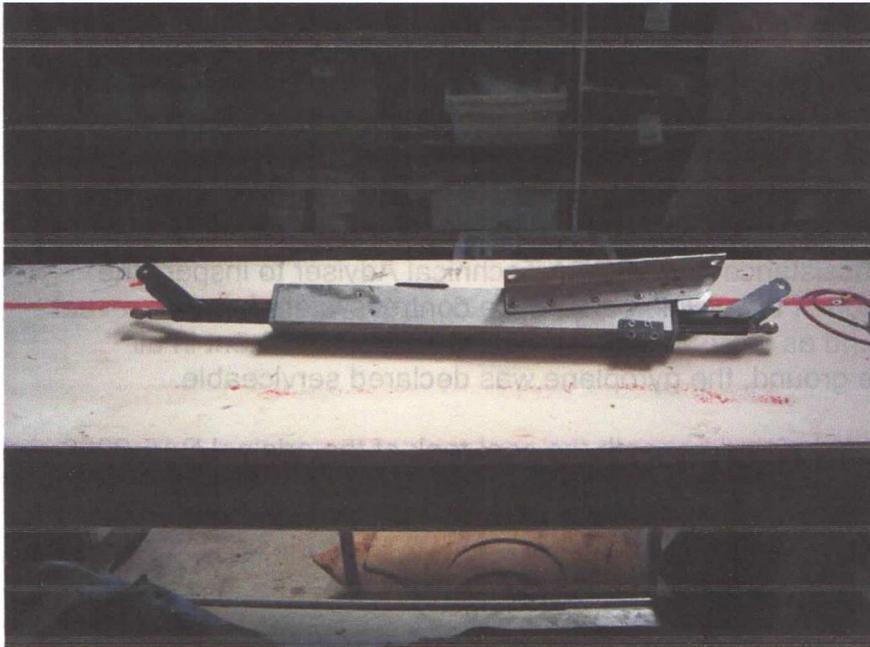
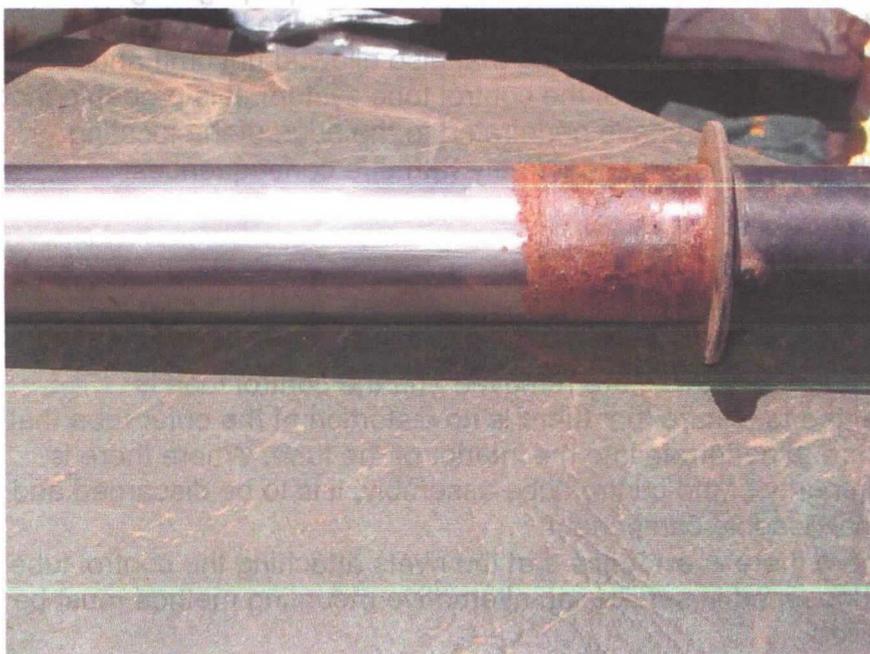
The control tube is located beneath the seat tank of the original RAF 2000, attached to the keel by means of locating plates and Stainless Steel rivets and cannot be inspected without removing the seat tank, an onerous task. When this item was removed from the accident gyroplane it exhibited significant signs of rust that had formed and accumulated on the lateral control tube causing it to bind in the neoprene plastic bush that is an integral part of the system. It is probable that distortion of the end cap of the control tube during manufacture allowed moisture to enter into the tube thus propagating the formation of rust. It was also noted that the rivet holes in the locating plates had elongated through in service working that also allowed uncommanded movement and possible jamming of the control tube system. It is probable that in time, the elongations would have penetrated to the edge of the locating plates allowing the control tube to float freely with dire consequences.

Although the direct cause of the control binding could not be positively established, it is strongly recommended that the seat tanks of RAF 2000 gyroplanes and their derivatives are removed and the control tube is thoroughly inspected to ensure that there is no distortion of the outer tube that may allow moisture to penetrate into the interior of the tube. Where there is doubt as to the integrity of the control tube assembly, it is to be discarded and replaced with a serviceable component. Furthermore, where there is evidence that the rivets attaching the control tube to the keel have loosened in service, an alternative mounting method must be devised and applied.

Upon completion, the work must be inspected by a suitably qualified ASRA Technical Adviser, or a person approved by the Operations Manager and the Gyroplane Log Book annotated accordingly and signed by the person who carried out the inspection.
