SAFETY ALERT

No: SA 2020.02

Subject: Magni M16 Rotax 912/914 Oil tank mounting bracket

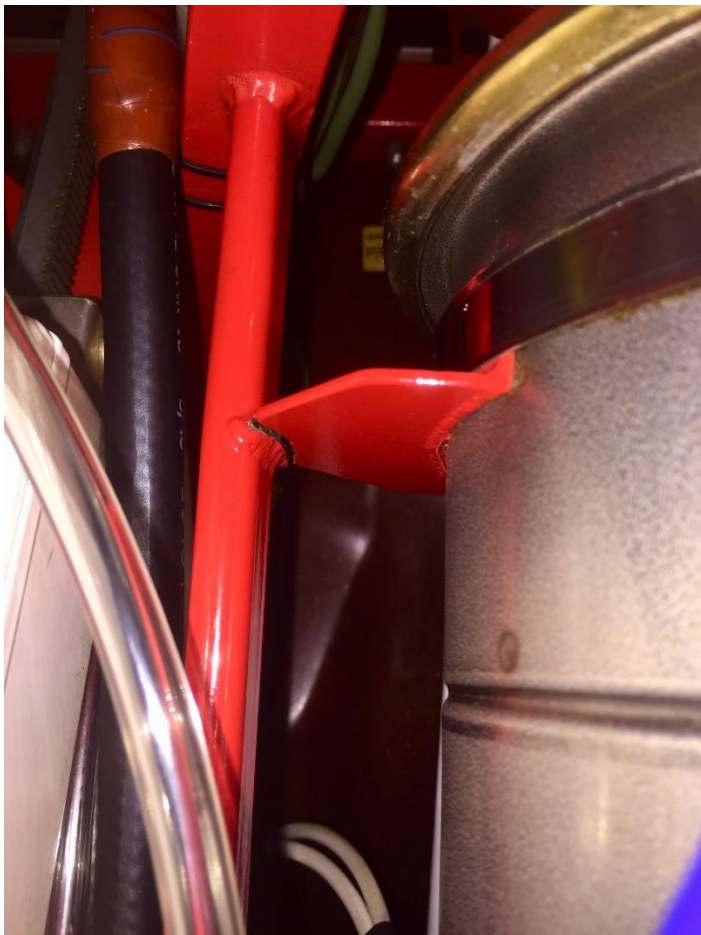
While carrying out routine cleaning & inspection, the pilot and owner of a Magni M16 gyroplane noticed the Rotax 912 Oil tank top horizontal support/mounting bracket to be cracked along the weld join and observed to be fully separated from the vertical support. The gyroplane had flown 630 hours.

It is recommended that Magni M16 pilots and owners complete an inspection of the Rotax 912 Oil tank top horizontal support/mounting bracket prior to the next flight and during pre-flight inspections
