SAFETY ALERT

No: SA 2015.01

Subject: Goodwin Seat Tanks

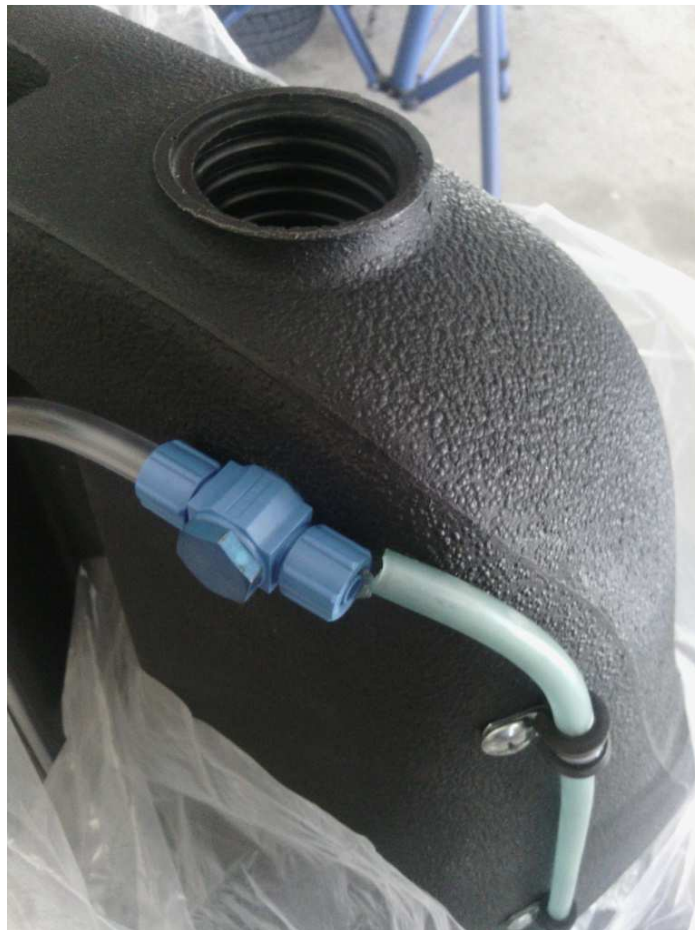
A report has been received from a gyroplane manufacturer in Australia that the sight gauge material used in these tanks is subject to failure without warning. In more than one case he has found that tanks supplied as brand new and still wrapped in plastic have been delivered with the sight gauge fractured. The reason(s) for the failures have not yet been established.

Information received from another gyroplane manufacturer in Australia confirms the defects reported by the first.

The consequences of an in-flight failure of the sight gauge at the point where it enters the lower tank fitting are obvious.

- ASRA strongly recommends that pilots, owners and operators of gyroplanes fitted with any size Goodwin seat tank cease operations immediately and replace the sight gauge with high quality tubing designed and manufactured specifically for use with petroleum products.

ASRA does not normally recommend a specific brand or type of material for use in situations such as this. However, one of the reporters of the defects states that he has had success with tubing manufactured in Italy known as “Ariete Green Double Skinned 6x9”. He states that it fits the tank fittings exactly and despite its name is actually purple in colour. Any “good” motor cycle spare parts store should stock it. Another likely source of good quality tubing is www.purplepig.com.au .
